Subject: Safety Inspection of Dams in North Carolina  
Per NCUC Order, Docket No.: E-100, Sub. 23  
Dan River Steam Station Ash Dikes  
File Nos.: SSS-0503, GAH-0202, SSS-0502

DAN RIVER STEAM STATION  
ASH BASIN DIKES  
ROCKINGHAM COUNTY, NORTH CAROLINA  
LETCo. Job No. CHW 5475

SECOND FIVE-YEAR INDEPENDENT CONSULTANT INSPECTION  
AS REQUIRED BY  
NORTH CAROLINA UTILITIES COMMISSION

JUNE, 1986

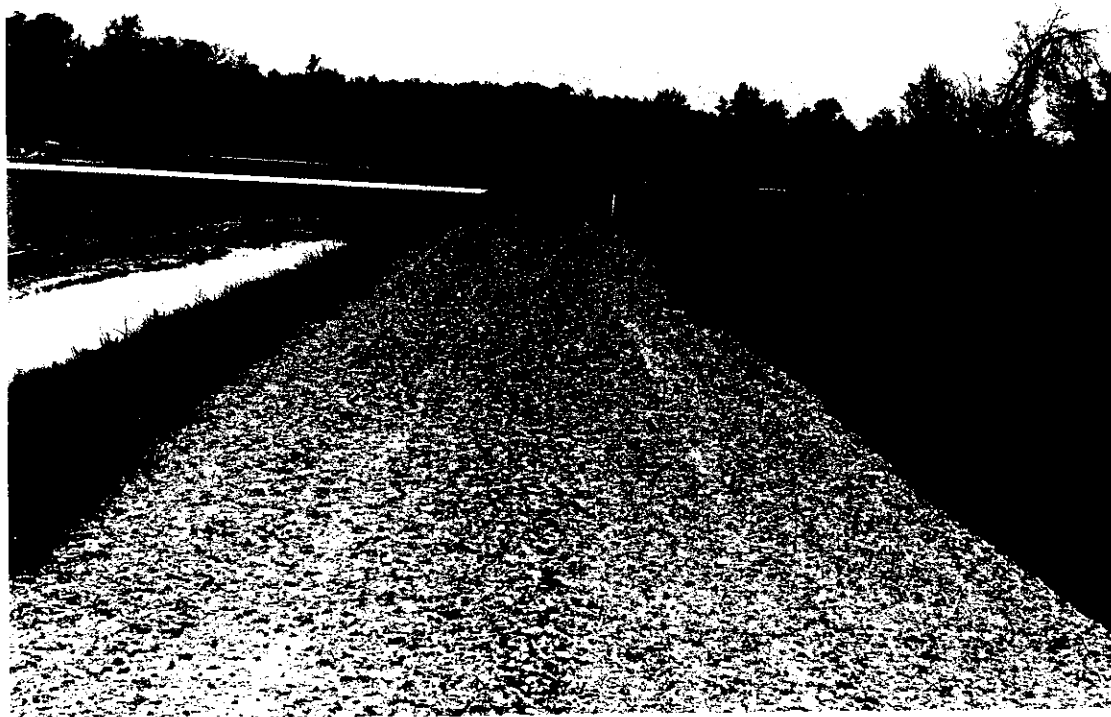
Typical views of the crests of the primary basin dike, secondary basin dike and intermediate dike are shown in Photos 4-1, 4-2 and 4-3, respectively. No obvious signs of settlement or displacement (tension cracking) were observed on the crests. The crest of the secondary basin dike had been resurfaced with

crusher run stone along most of its length; this resurfacing filled-in ruts that were noted in the last independent inspection. The intermediate dike also appeared to have new crusher run surfacing. Grass was observed to be growing through the crusher run surfacing along the centerline of the primary basin dike. Overall, the dike crests were observed to be in good condition.

PHOTO 4-2 CREST OF SECONDARY BASIN DIKE  
(TYPICAL VIEW)

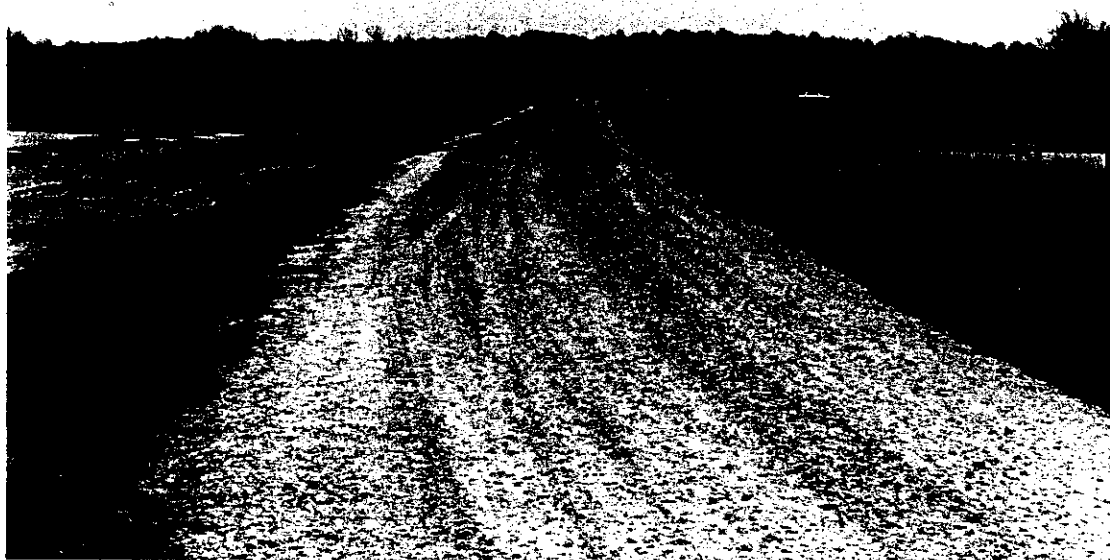
PHOTO 4-3 CREST OF INTERMEDIATE DIKE  
(TYPICAL VIEW)

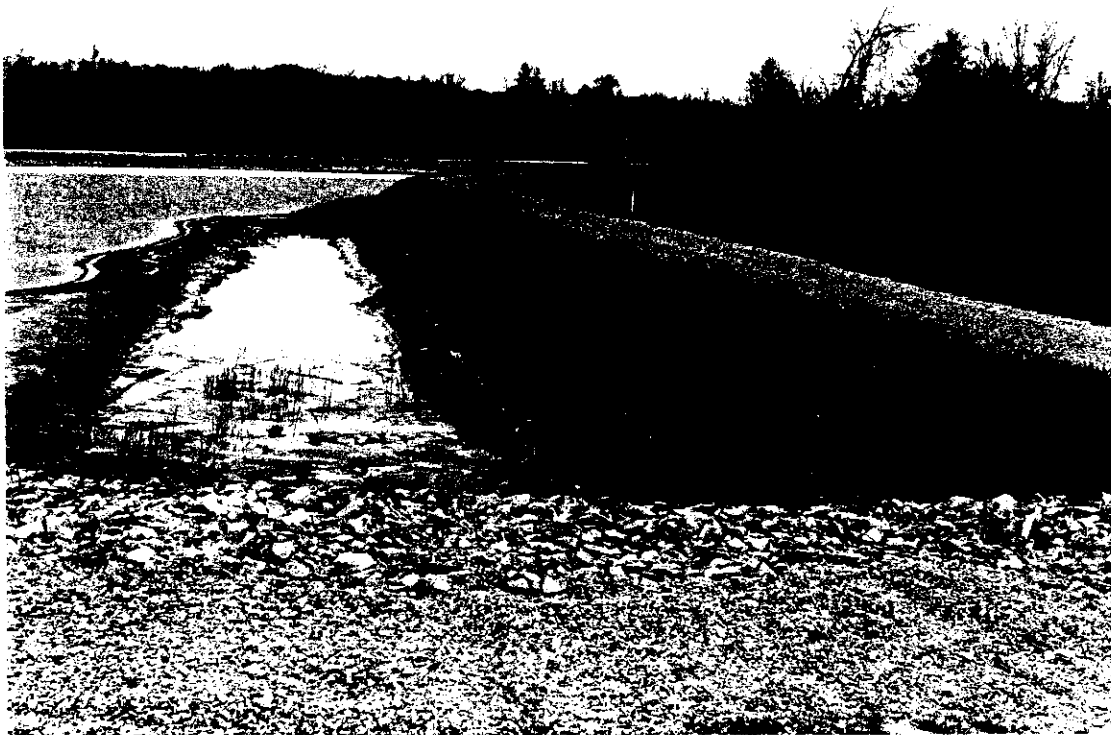
The inside (upstream) slopes of the dikes were observed to have a good grass growth that had been recently mowed down to the normal water levels in the basins. Typical views of the inside slopes of the primary basin dike and the secondary basin dike are shown in Photos 4-4 and 4-5, respectively; a typical view of the upstream (primary basin) side of the intermediate dike is shown in Photo 4-6. No slumps, slides or significant surface erosion were observed on the inside slopes of the dikes. There still is some minor wave erosion on the inside slope of the secondary basin dike. Wave erosion that was noted on the upstream side of the intermediate dike in the 1981 inspection was not noticeable in this current inspection due to ash build-up on the slope and growth of vegetation. In the primary basin the ash surface was observed to be above water level in much of the basin, and it generally was overgrown with vegetation.

PHOTO 4-5    INSIDE SLOPE OF SECONDARY BASIN DIKE  
                  (TYPICAL VIEW)

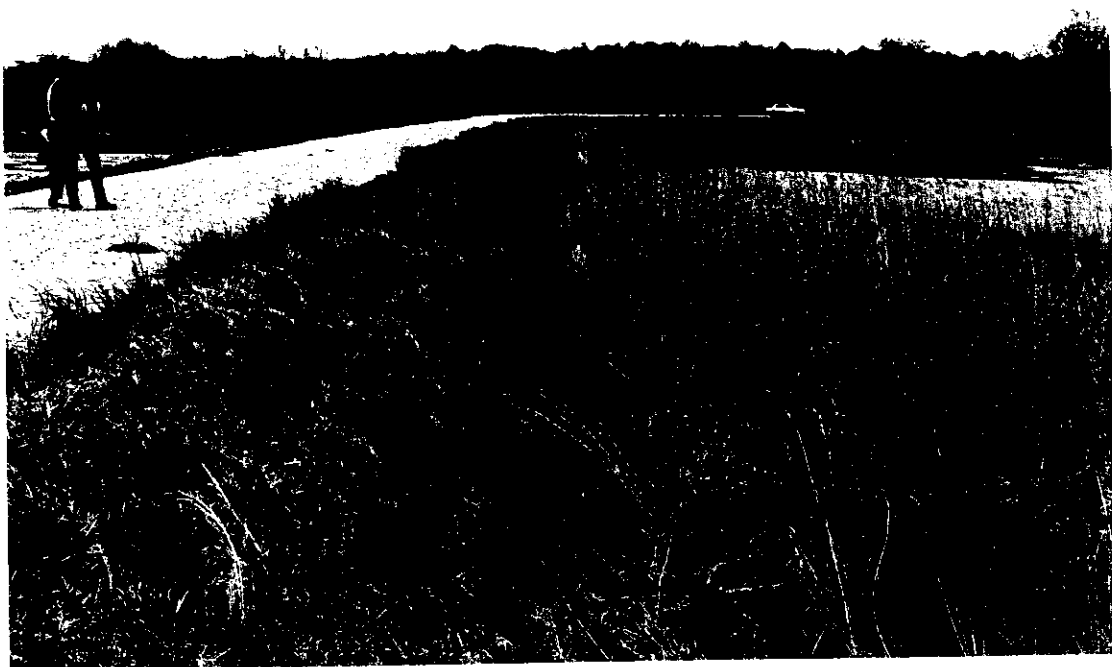
PHOTO 4-6    UPSTREAM SIDE OF INTERMEDIATE DIKE  
                  (TYPICAL VIEW)

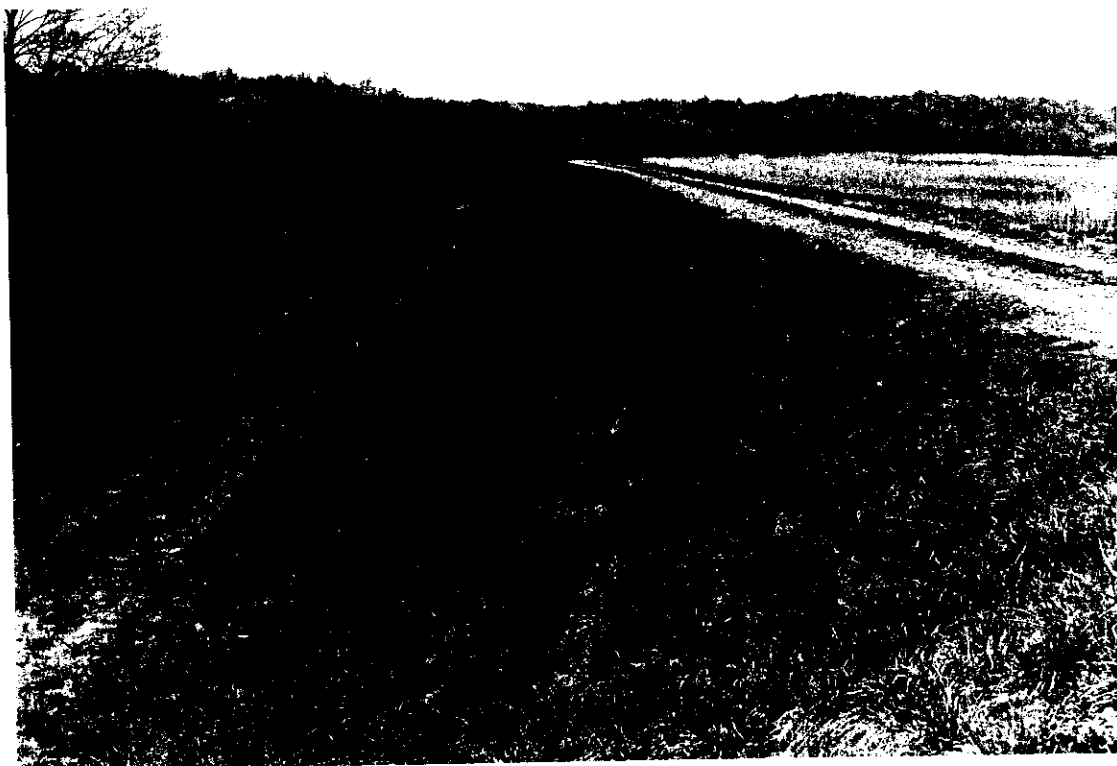
The lower portions of the outside slopes of the primary and secondary basin dikes next to the river were observed to still be heavily overgrown with trees, bushes, briars and other vegetation as was observed in the 1981 inspection. The outside slope of the raised portion of the primary basin dike and the upper part of the outside slope of the secondary basin dike were observed to have a grass cover as shown in Photos 4-7 and 4-8, respectively. No slumps, slides or major

PHOTO 4-7 OUTSIDE SLOPE OF RAISED PORTION OF PRIMARY  
BASIN DIKE NEXT TO RIVER

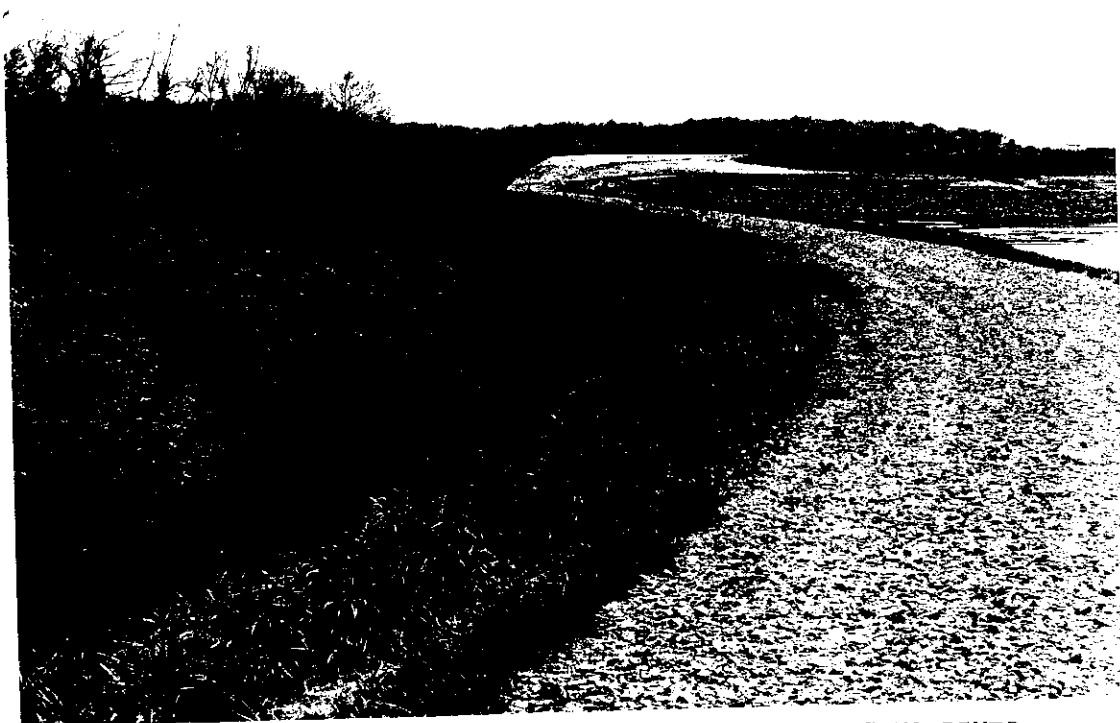
PHOTO 4-8 OUTSIDE SLOPE OF SECONDARY BASIN DIKE NEXT TO RIVER

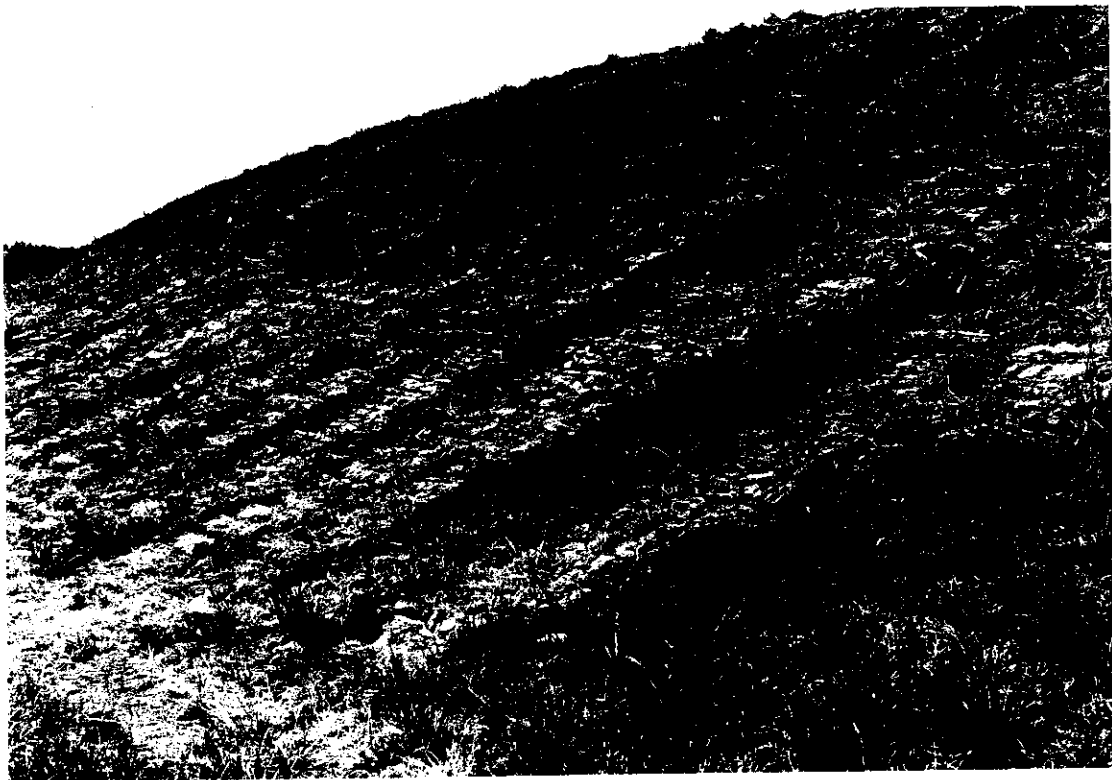
erosion were observed on the more visible, grassed portions of the slopes. Close inspection for slumps, slides or other evidence of shear failure on the lower portions of the slopes next to the river was not possible due to the dense vegetation, but none of these conditions was obvious except for a very old slump area, shown in Photo 4-9, of limited extent on the outer slope above the rockfill berm at the primary basin dike; the old slump was barely noticeable and showed no signs of recent movement. At many locations on the outside slope of the primary basin dike there were bare soil areas that had recently been tracked with a dozer and hydroseeded; one of these areas is shown in Photo 4-10.

PHOTO 4-10 TYPICAL VIEW OF REPAIRS TO BARE SOIL AREAS ON PRIMARY  
BASIN OUTSIDE SLOPE (TRACKED WITH DOZER AND HYDROSEEDDED)

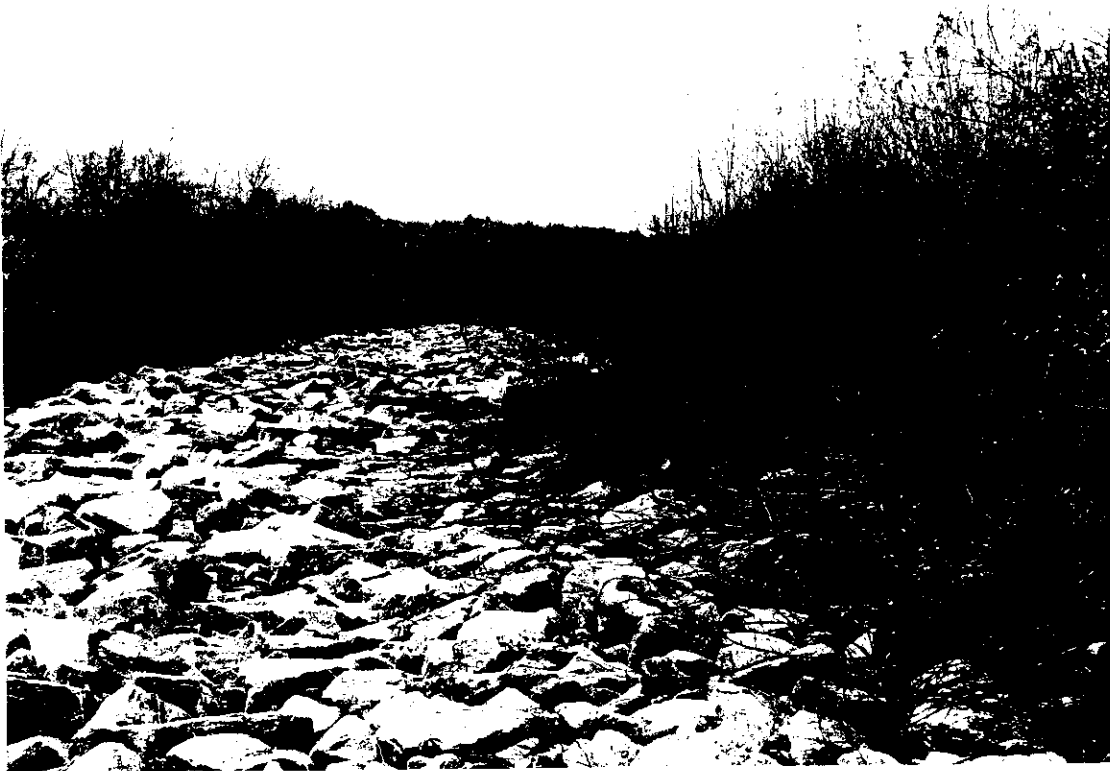
The rockfill berm at the base of the primary basin dike next to the river was observed to be in good condition though vegetation is beginning to overgrow the berm in places as shown in Photo 4-11. A shallow animal hole was noted at one location in the primary basin dike slope just above the rockfill berm.

PHOTO 4-11 ROCKFILL BERM AT BASE OF PRIMARY BASIN DIKE NEXT TO RIVER

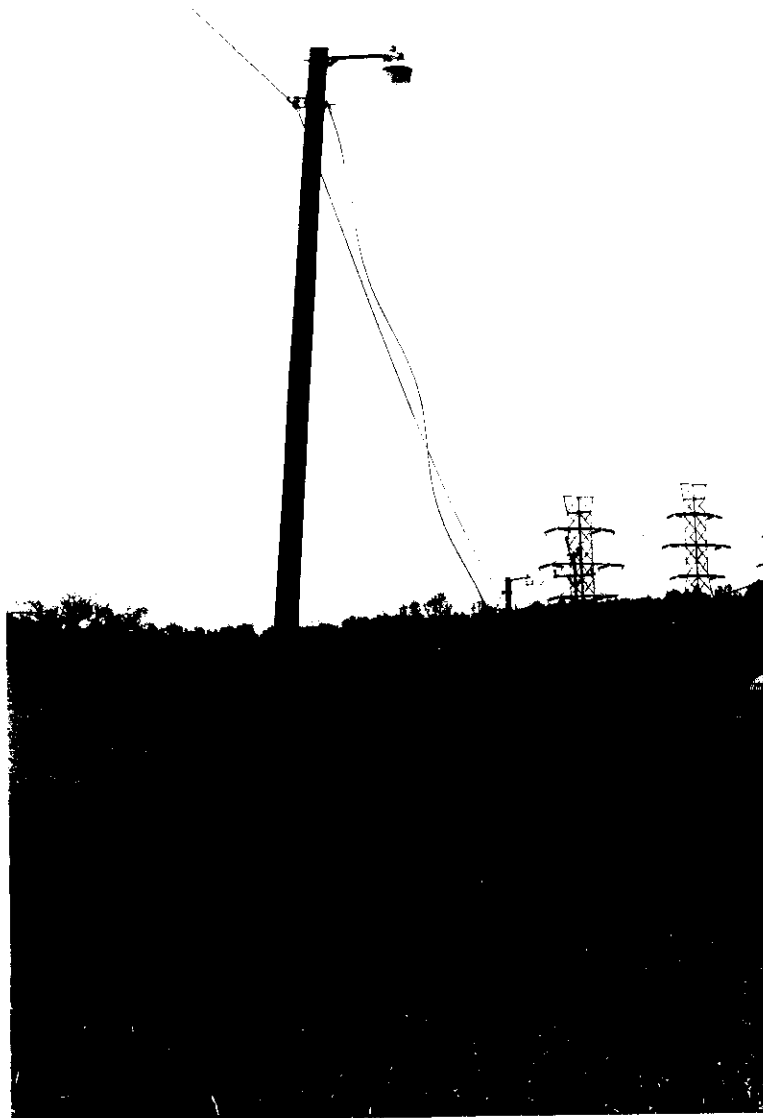
A light pole located on the outside slope of the raised portion of the primary basin dike next to the plant entrance road, near where the road veers away from the dike and toward the plant, was observed to be leaning out at the top away from the dike as evidenced by the slack guy wire shown in Photo 4-12. Between this pole and the next pole to the north a slight "bulge" or "hump" in the outside slope was noticed as shown in Photo 4-13. The next pole to the north was also observed to be leaning slightly.

PHOTO 4-12 LEANING LIGHT POLE ON PRIMARY BASIN DIKE NEXT TO PLANT  
ENTRANCE ROAD

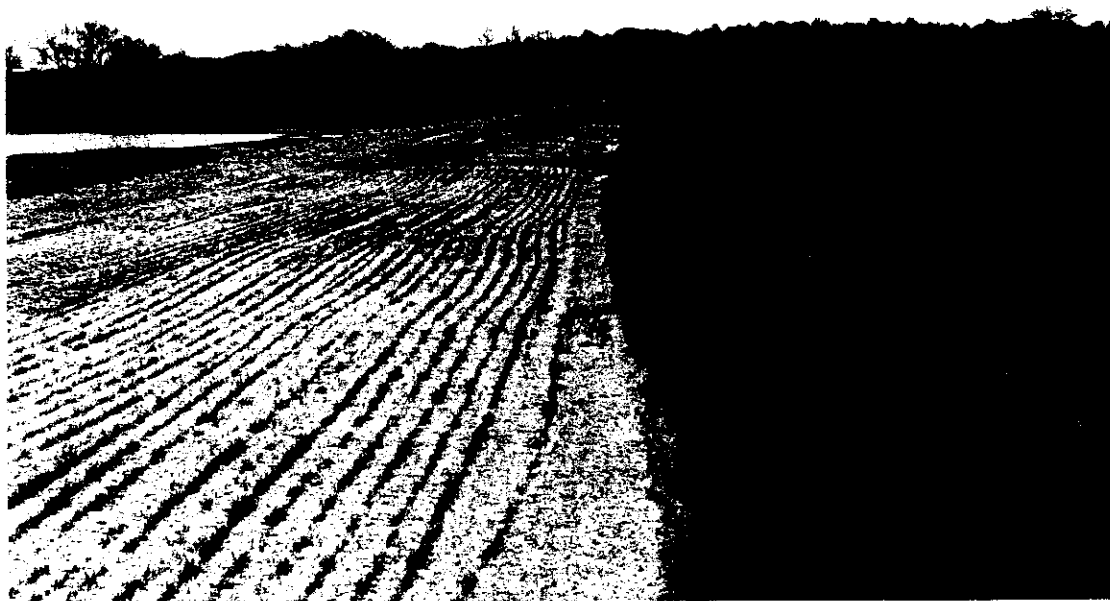
A view of the newly constructed berm on the secondary basin side of the intermediate dike is shown in Photo 4-16. As shown, only one level of the berm is evident; it appeared to be at or near the upper level of the two-level berm called for by design. Grassing had not yet become well established on the berm surface, except along the drainage swales where Excelsior blanket had been installed. No tension cracks, depressions, slumps or other signs of instability were observed on the berm or along its riprapped toe. Evidence of small boils in the ash at the toe of the berm was noted at one location, as shown in Photo 4-17, near the southeast quarter point of the dike. The boils were not active at the time of inspection. A small flow of clear seepage was observed emerging from the riprapped toe (visible in Photo 4-17).

PHOTO 4-16 NEW BERM ON SECONDARY BASIN SIDE OF INTERMEDIATE DIKE

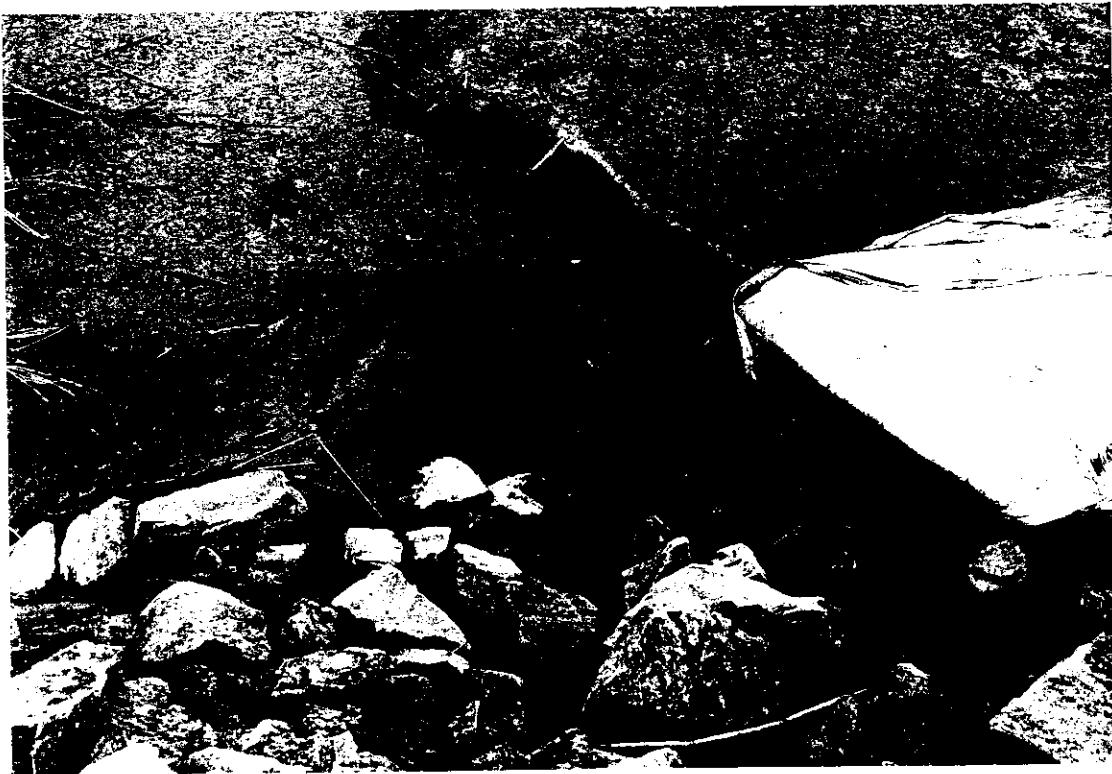
PHOTO 4-17 EVIDENCE OF SMALL BOILS IN ASH AT TOE OF NEW BERM  
(BOILS NOT ACTIVE) AND CLEAR SEEPAGE

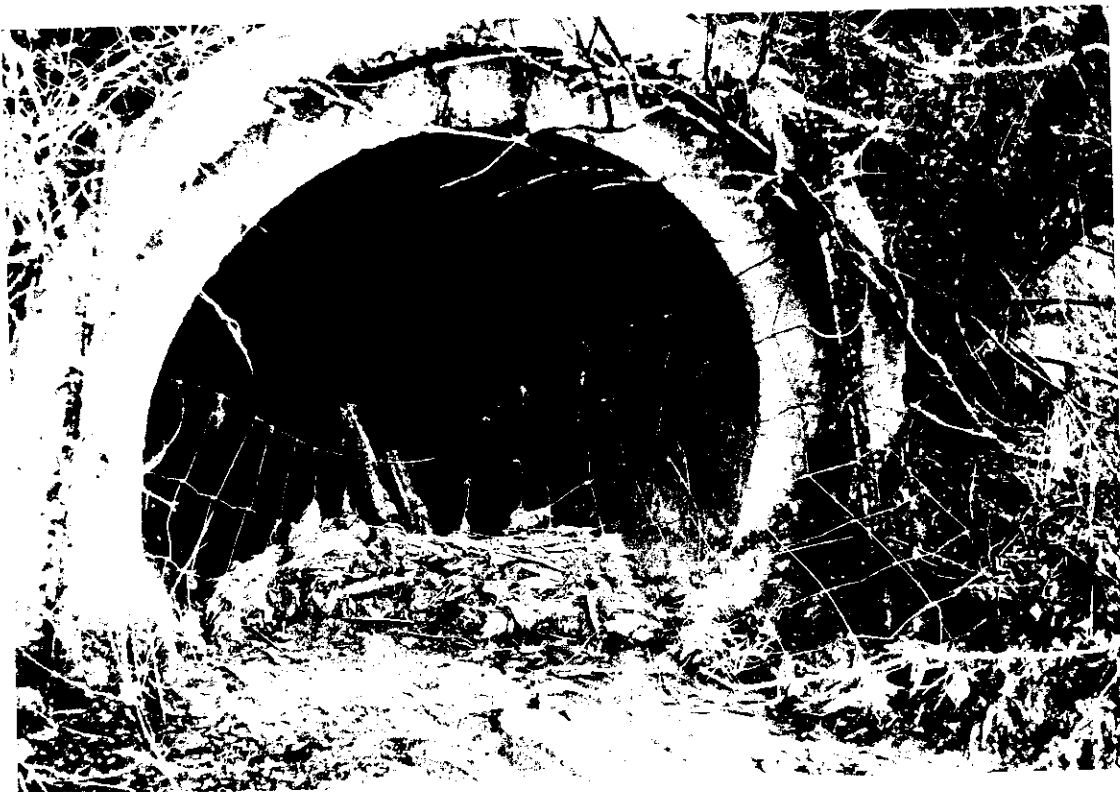
The entrance end of the easternmost culvert (52/36-inch diameter lines) that passes beneath the ash basin is shown in Photo 4-18. Seepage from the banks of the drainage swale upgradient of the entrance still flows into the culvert. A build-up of sediment was observed at the entrance as shown in Photo 4-18. The outlet end of this culvert is shown in Photo 4-19. A close-up inspection of the water being discharged revealed no sediment or ash being carried by the water. The concrete apron below the outlet was observed to be cracked and undermined. The outlet end of the other culvert (48-inch diameter line) which passes beneath the middle of the primary basin is shown in Photo 4-20. The water flowing from this culvert was observed to be clear in a close-up inspection.

PHOTO 4-18 ENTRANCE END OF 52/36-INCH RCP CULVERT

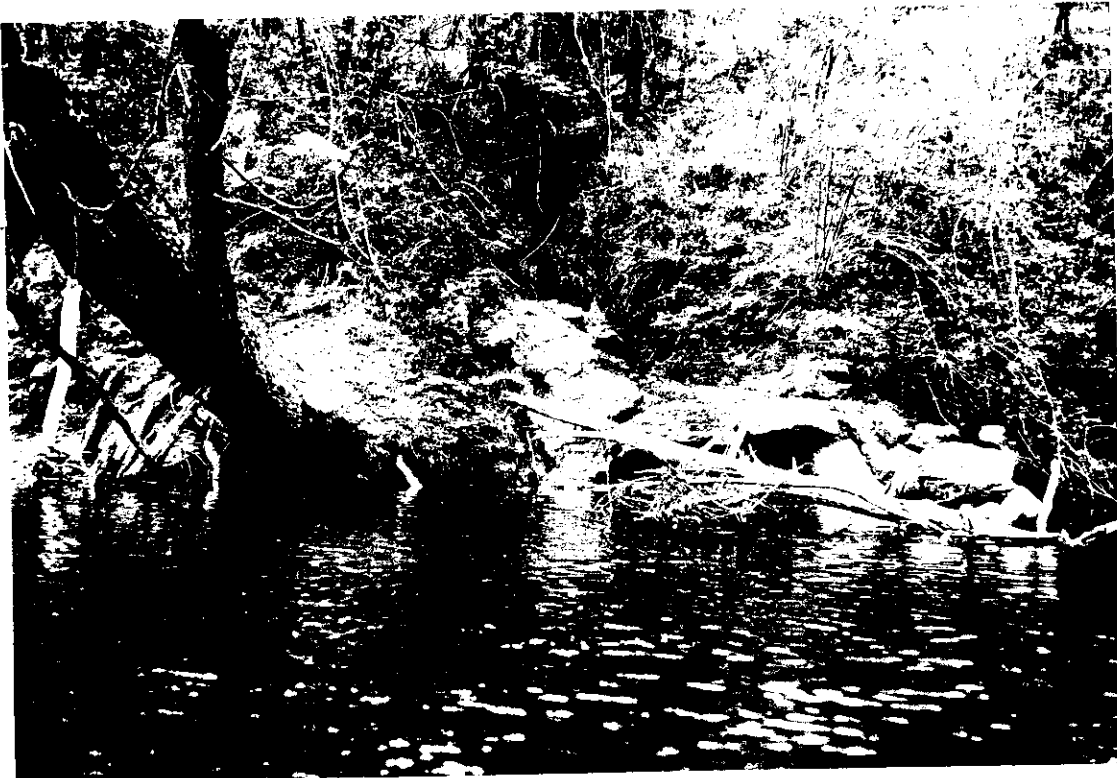
PHOTO 4-19 OUTLET END OF 36-INCH RCP SECTION OF 52/36-INCH  
CULVERT BENEATH ASH BASIN

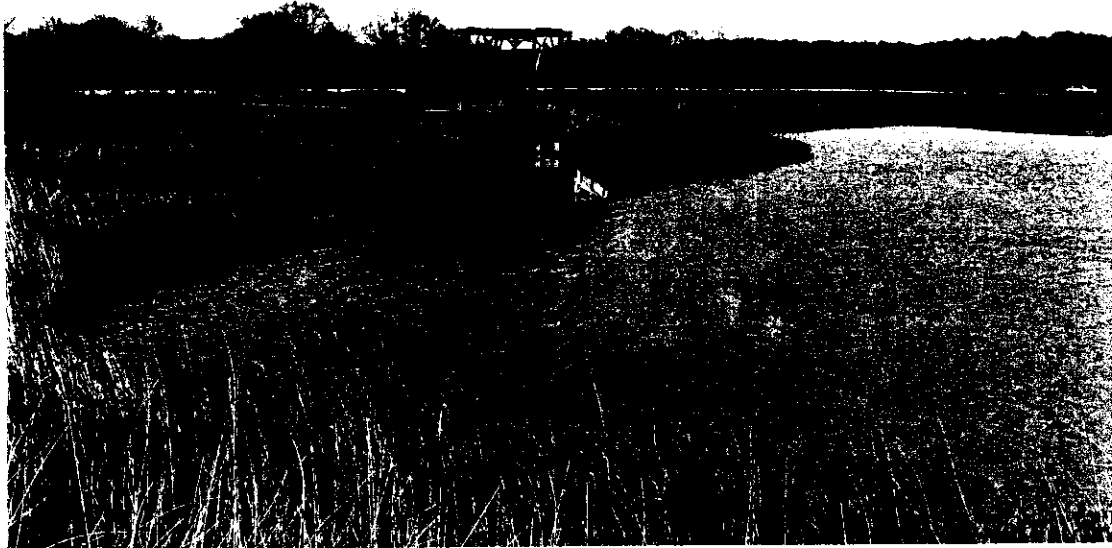
The visible part of the primary drainage tower is shown in Photo 4-21, and the downstream end of the 36-inch diameter reinforced concrete pipe (RCP) outlet for the tower is shown in Photo 4-22. The drainage tower appeared to be in good condition except for the rusty steel frame on top of the tower. Also, ash was observed to be built-up around much of the tower perimeter, and the skimmer structure was observed to be grounded on the ash. No dropouts were observed in the embankment material over the outlet pipe; no seepage was observed around the outlet end of the pipe.

PHOTO 4-21 VIEW OF PRIMARY BASIN DRAINAGE TOWER

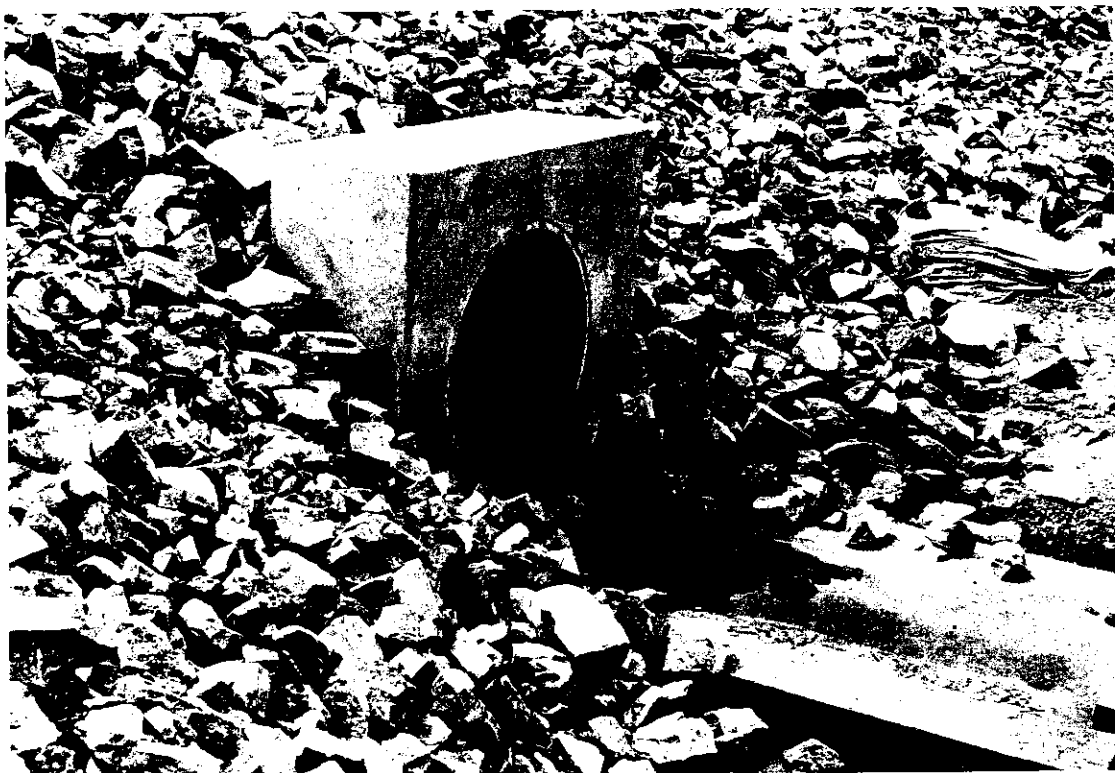
PHOTO 4-22 OUTLET END OF 36-INCH RCP PRIMARY BASIN OUTLET

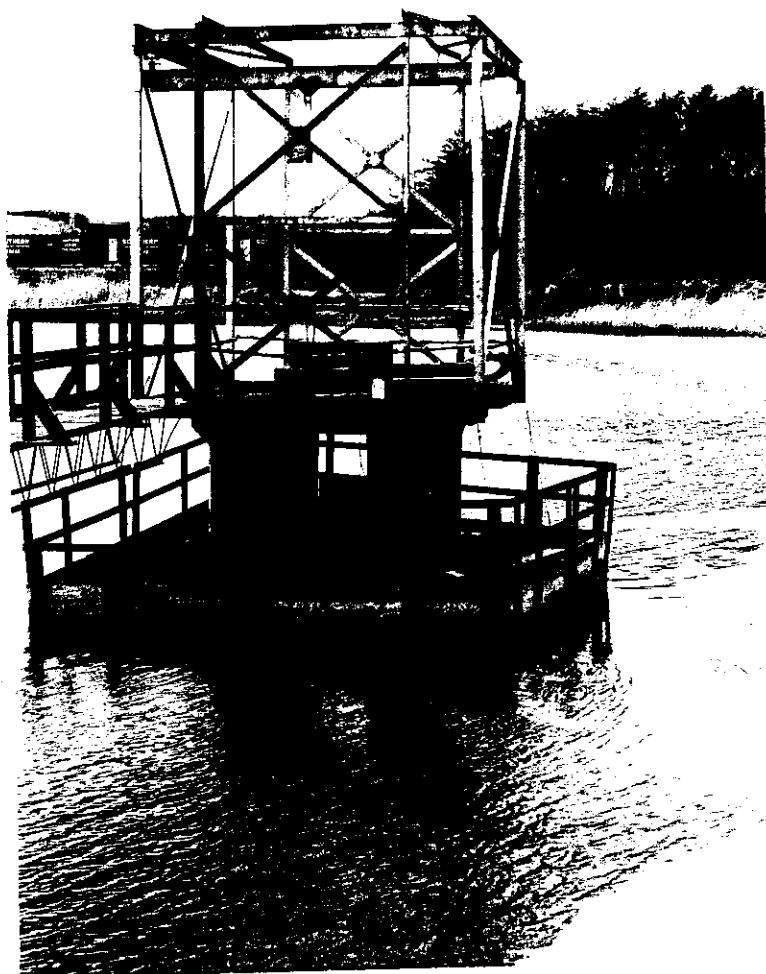
The visible part of the secondary drainage tower is shown in Photo 4-23; the outlet end of the 36-inch diameter reinforced concrete discharge pipe is shown in Photo 4-24. These structures also appeared to be in good condition though the steel frame on top of the drainage tower is also rusted. No obvious signs of seepage and piping of soils around the outlet pipe were observed. The discharge from the pipe was clear flowing.

PHOTO 4-23 VIEW OF SECONDARY BASIN DRAINAGE TOWER

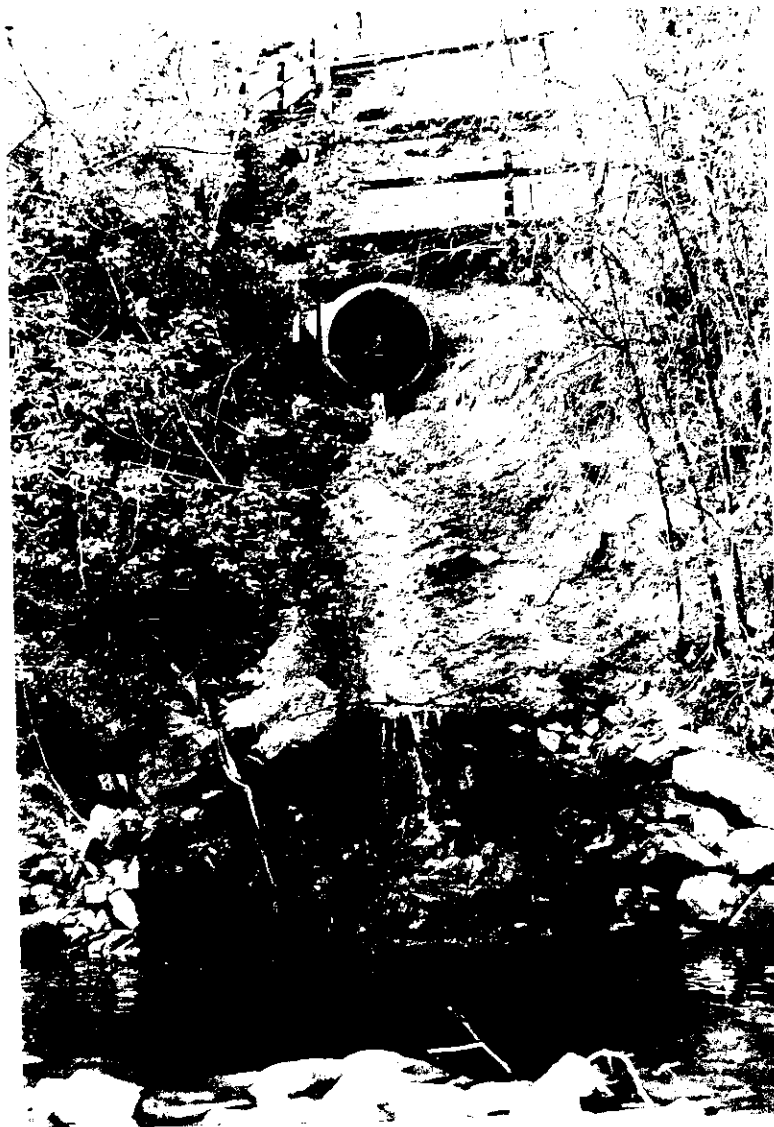
PHOTO 4-24 OUTLET END OF 36-INCH RCP SECONDARY BASIN OUTLET

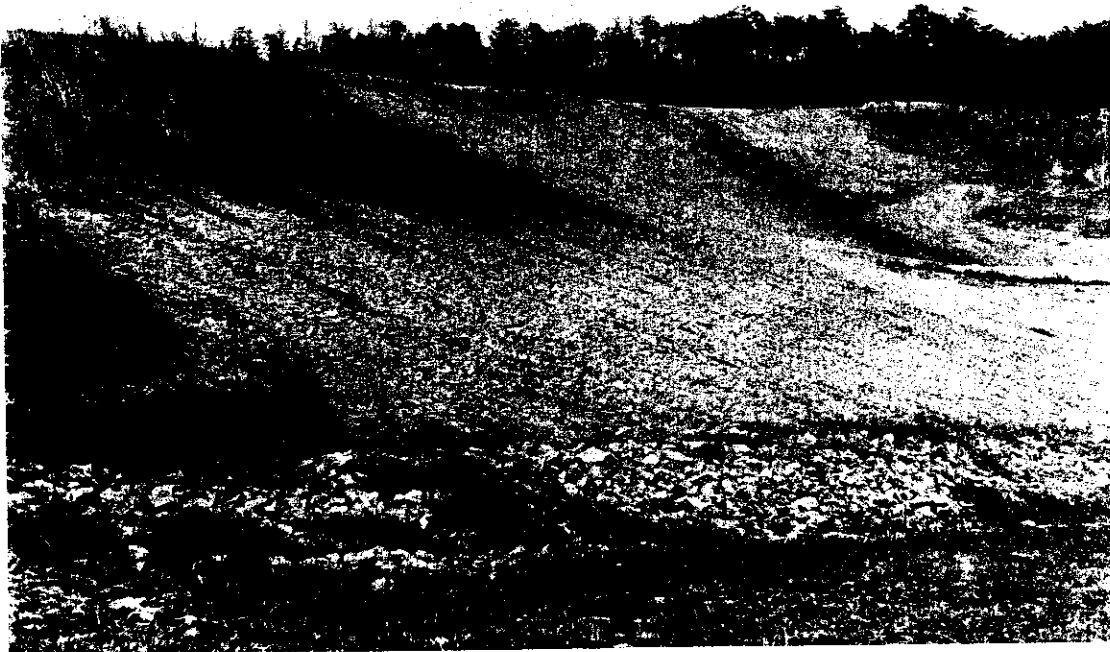
The crest, upstream slope and downstream slope of the maximum height section of the dry ash storage basin dike are shown in Photos 4-25, 4-26 and 4-27, respectively. As shown, grass has not been very well established on the slopes of this dike. However, the slopes recently had been tracked with a dozer and hydroseeded. No tension cracks or significant depressions were observed on the crest, and no slumps, slides or other signs of shear failure were observed on either the upstream or downstream slopes. Some seepage or wet areas were observed just below the toe drains at the higher sections of the northeast and southwest portions of the dike. A view of the wet area at the toe of the southwest portion of the dike is shown in Photo 4-28; this is typical of the wet conditions observed. Some of the seepage from this area comes from a spring in natural ground down-gradient of the toe, rather than from the toe drain.

PHOTO 4-27 DOWNSTREAM SLOPE OF MAXIMUM HEIGHT SECTION  
OF DRY ASH STORAGE BASIN DIKE (SW TO NE VIEW)

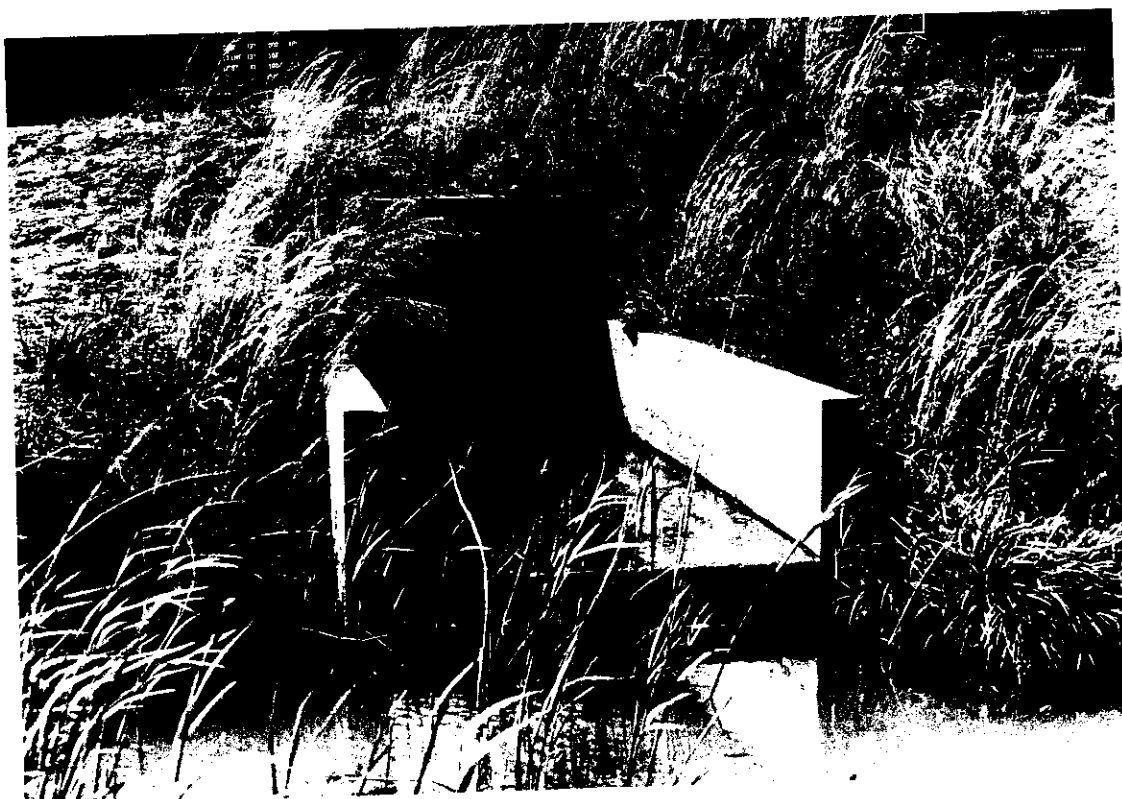
The dry ash basin drainage tower is shown in Photo 4-29, and the outlet end of the 36-inch diameter RC bottom discharge pipe is shown in Photo 4-30. These structures were in good visual condition. Some trash was accumulated on the bar screens of the drainage tower. No dropouts or leakage were observed in the embankment soils where the outlet pipe is buried through the dike and railroad embankment.

PHOTO 4-30 OUTLET END OF 36-INCH RCP OUTLET FOR DRY ASH STORAGE BASIN
